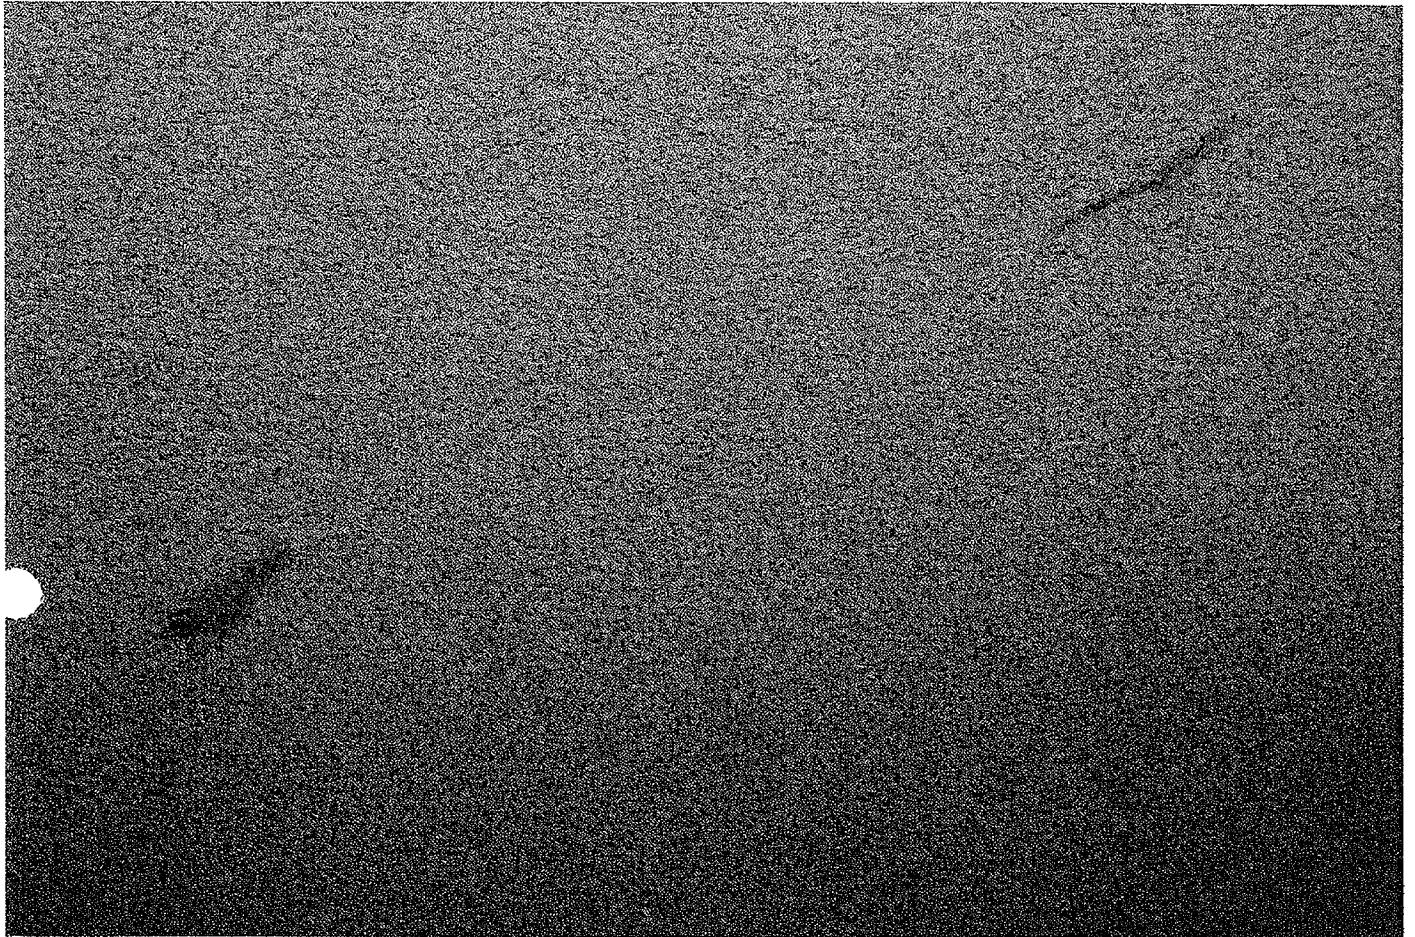
145. Visiting Area - Impact damaged acoustical plaster ceiling

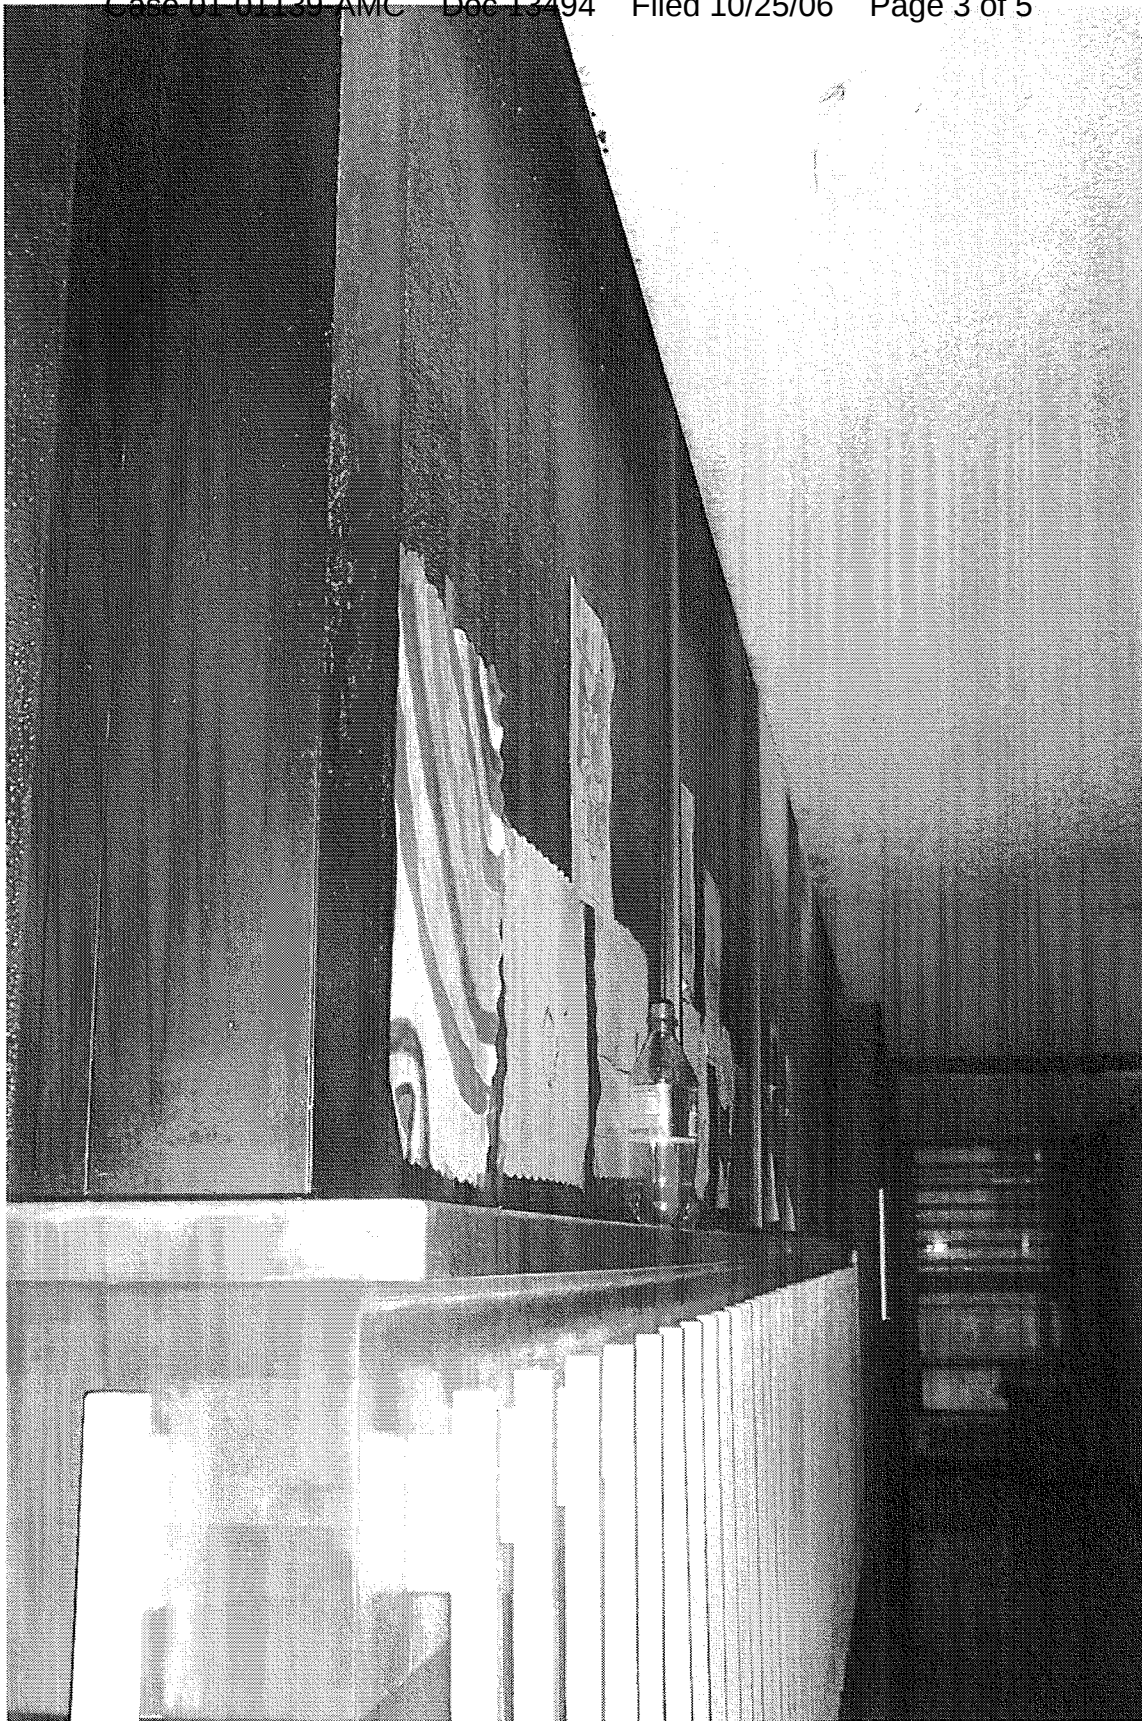
147. Lower Day Area, behind stairs - Location of dust sample #1 (top of wood railing)

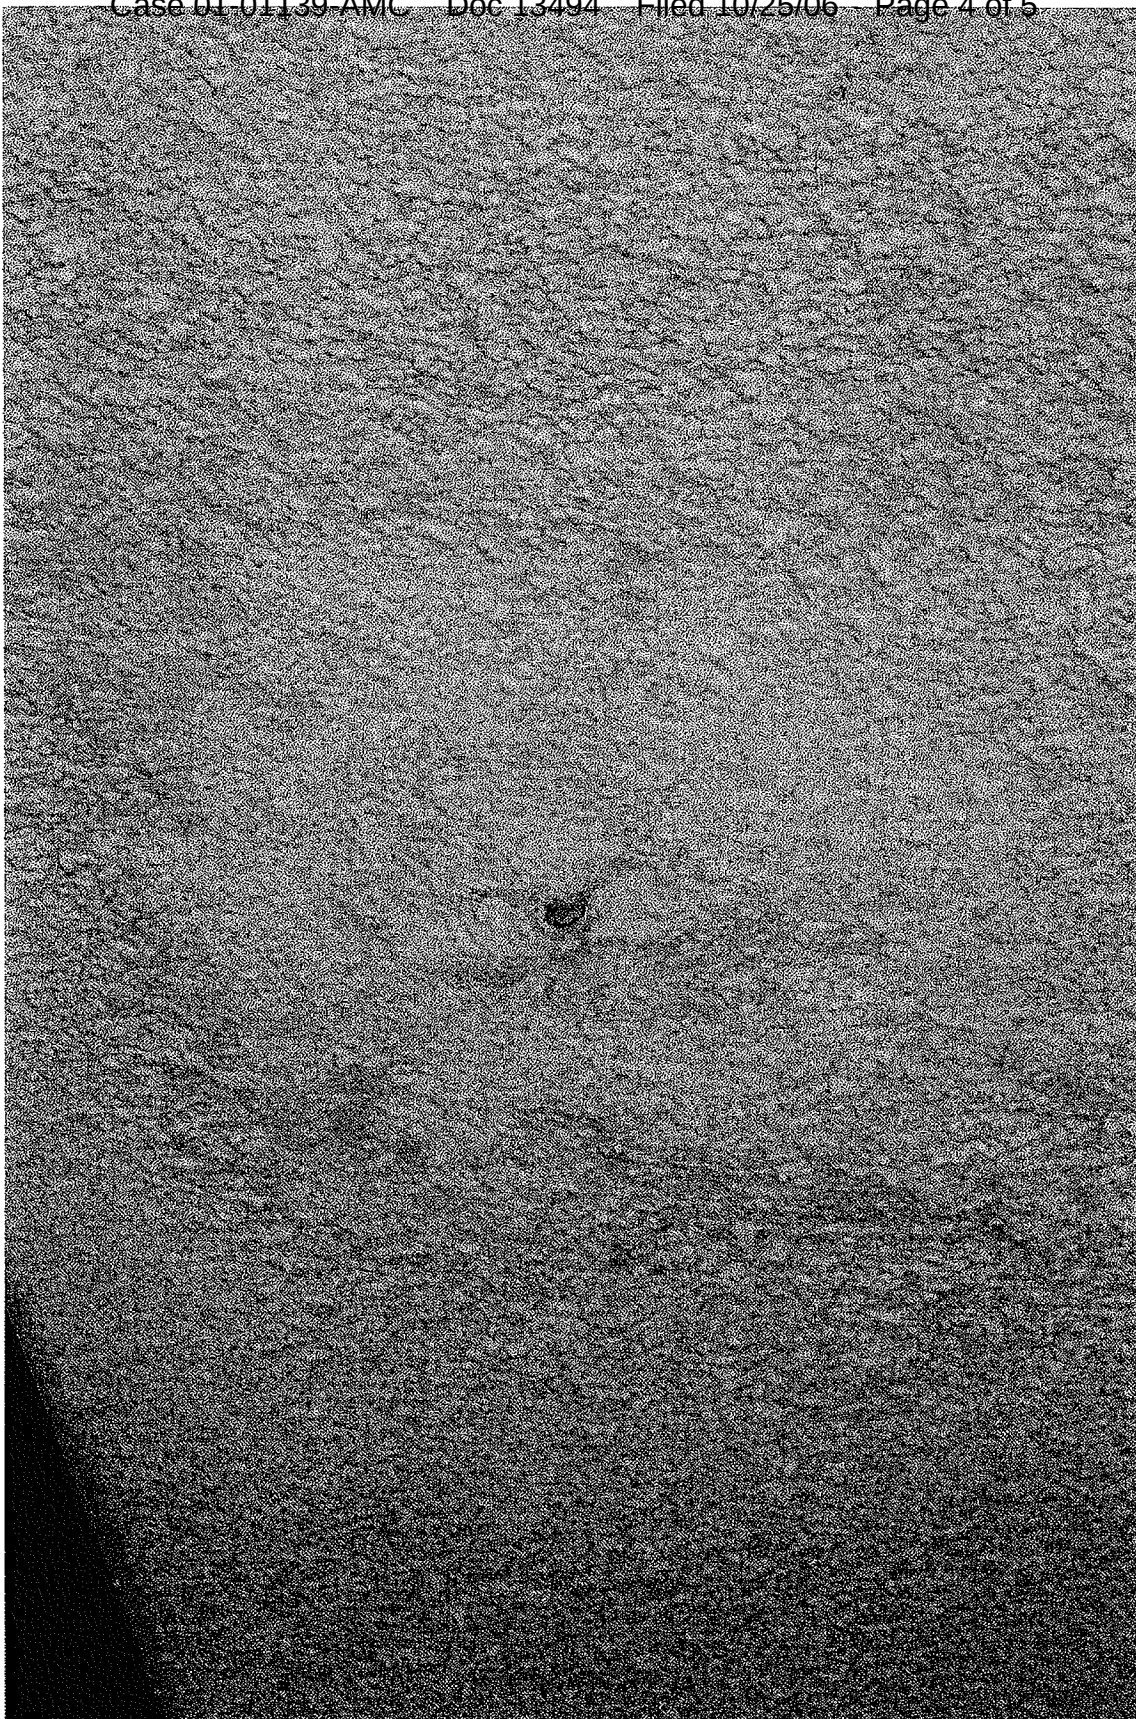
148. Hallway outside Office Area - Water damaged acoustical plaster ceiling

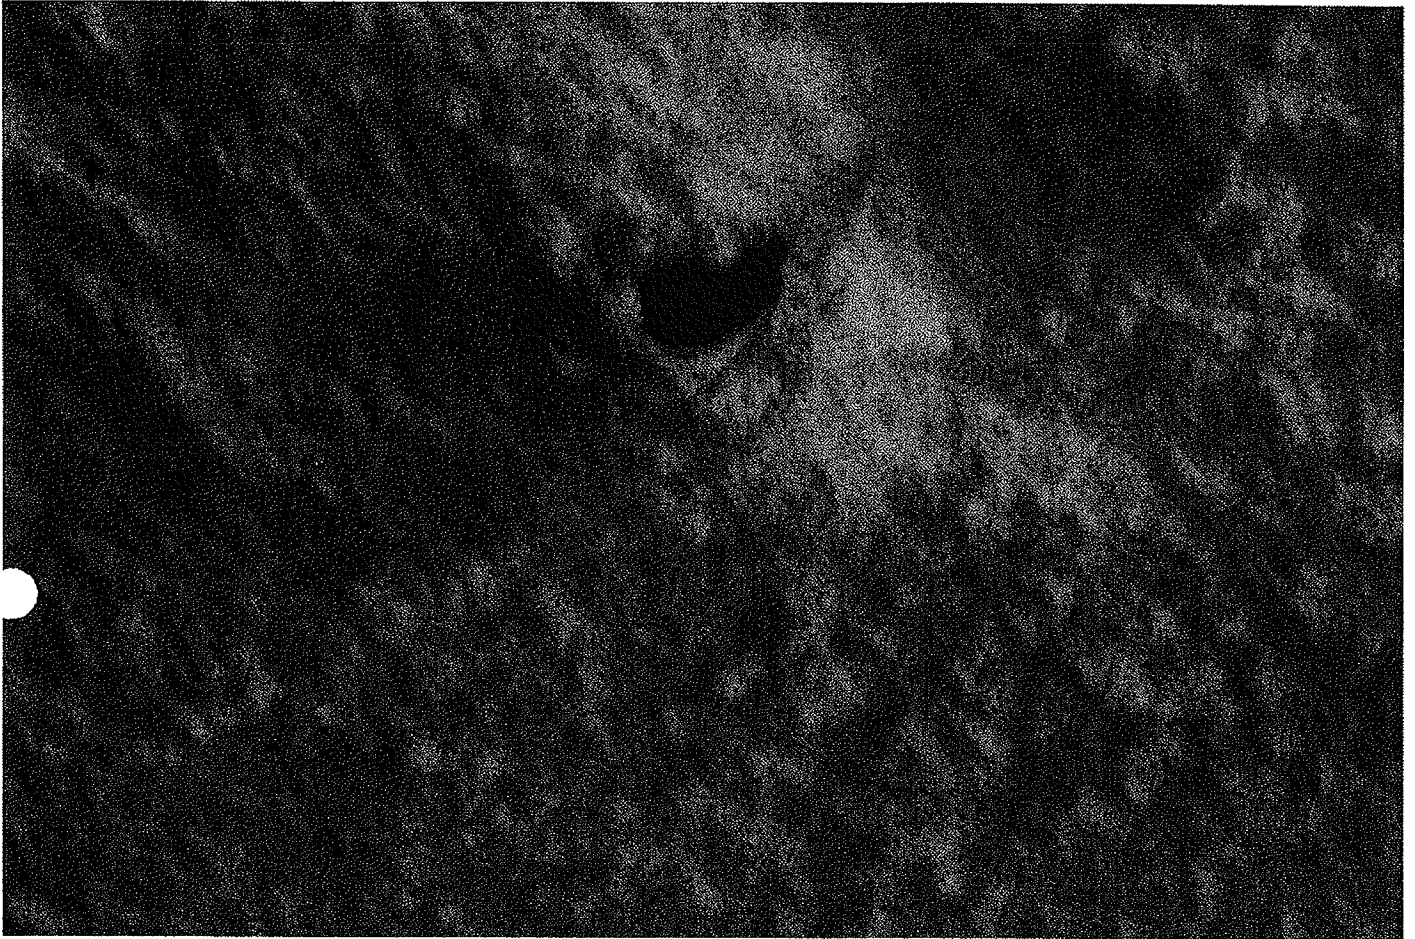
149. Hallway outside Office Area - Close-up of water damaged acoustical plaster ceiling
